CASE STUDY

Customized Solution for High Temperature Environment

FURON®

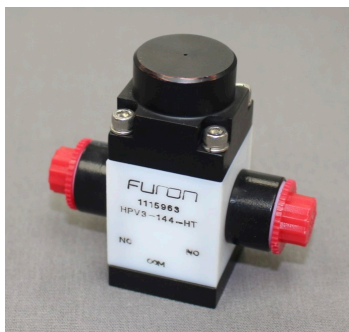
Customized Furon HPV HT 3-Way with High Temperature Features

Our solution to this temperature issue was to offer the same valve, but customized with a black, anodized aluminum actuator housing. When aluminum is anodized, the surface becomes three times harder than standard aluminum, and will not flake, peel or chip, protecting the actuator mechanism from unwanted particles. Because the anodization process is controlled oxidation of the aluminum, the product will never rust, patina, or weather. This lightweight metal can withstand temperatures up to 1221°F (605°C). The body of the valve is made from PTFE, so it is ideal for their elevated ambient temperature.
